Lake James Croxtan Ditch Watershed Feasibility Study

William W. Hill and Associates

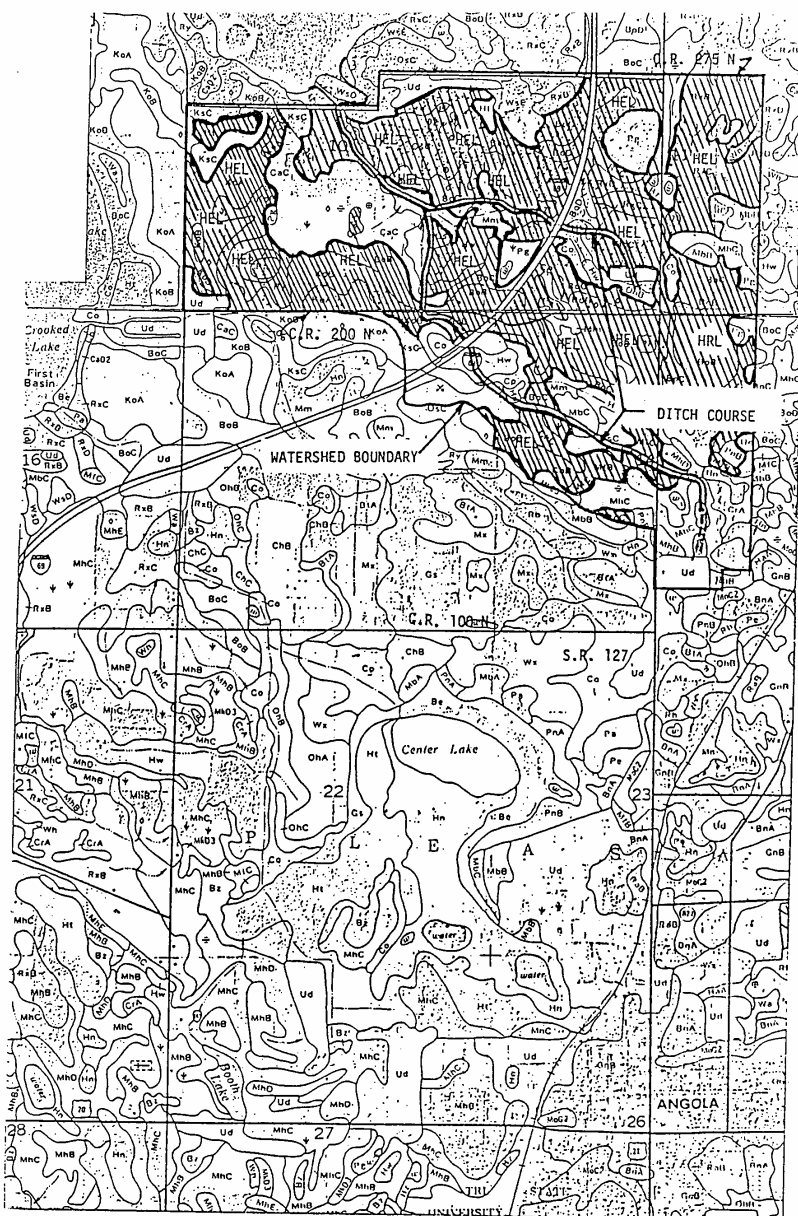
Figure XI. The John Croxton Ditch; Soil Identification

— Ditch Course — Watershed Boundary Highly Erodible Soils (HEL)
Scale: 1/20000

Soils Soil type information from the 1981 county survey is presented in Figure XI. The major direct impact of soil type on the situation under study is the susceptibility to erosion under the influence by wind and water. Some soil types are more prone to erosion because of their physical characteristics, steepness and length of slope, and direct contact with wind and water. The presence of residue and living vegetation can greatly reduce erosion on these potentially erosive soils.

Identified in Figure XI are the soils classified by a average to high value of erosion factor K and also in the wind erodible groups 1, 2 or 3. These soils can be classified as highly erodible, and comprise approximately 70% of the
